ArmorGalv® for nails

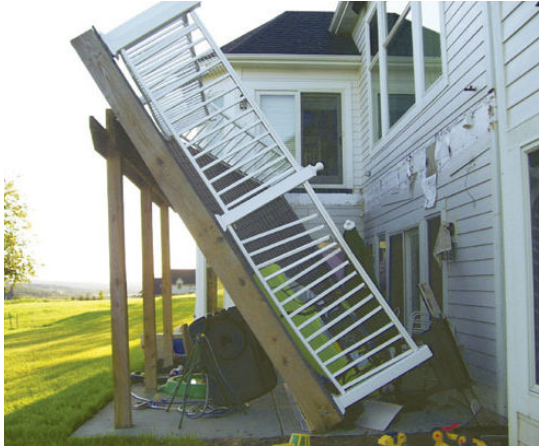
Typical deck collapse due to corroded fasteners

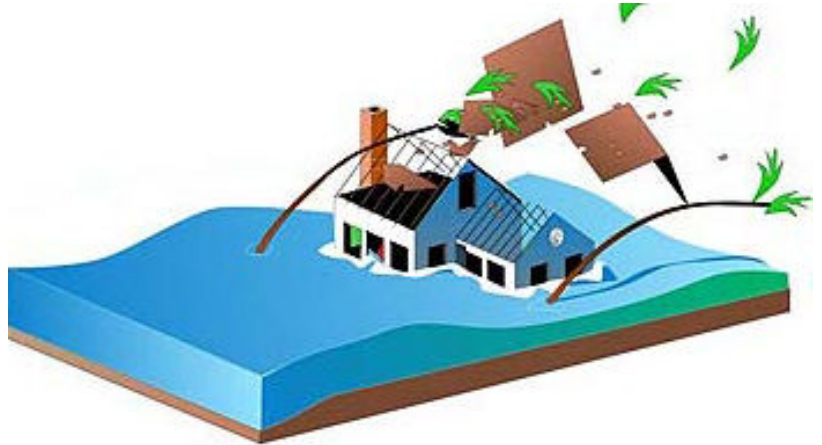
This is what happens in a storm, if fasteners corrode and no longer have the holding power required to hold the roof in place.

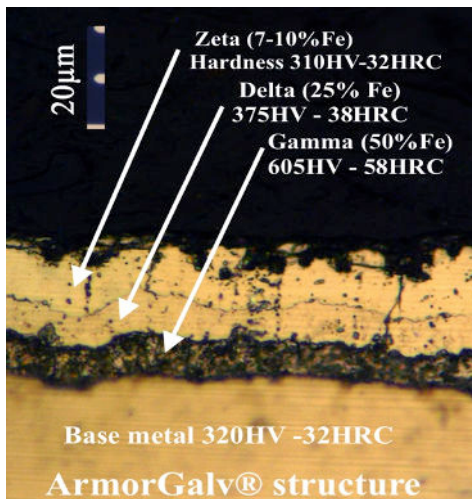
ArmorGalv® Cross section

M6 cap head screw with captive washer

ArmorGalv® is not merely a sacrificial coating. It diffuses zinc atoms into the surface of any steel part, creating a zinc/iron alloy, which has proven to last decades in the most severe environments.

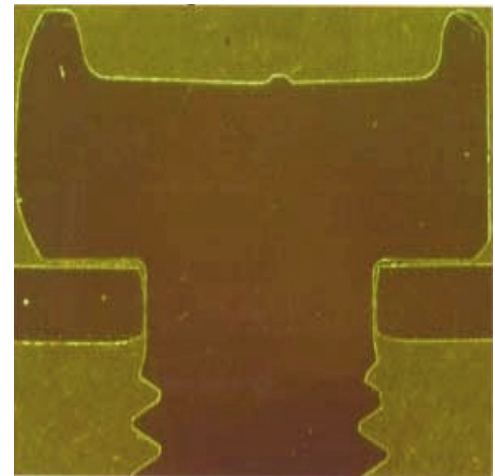
Cross section of cap screw showing precision and uniformity of coating

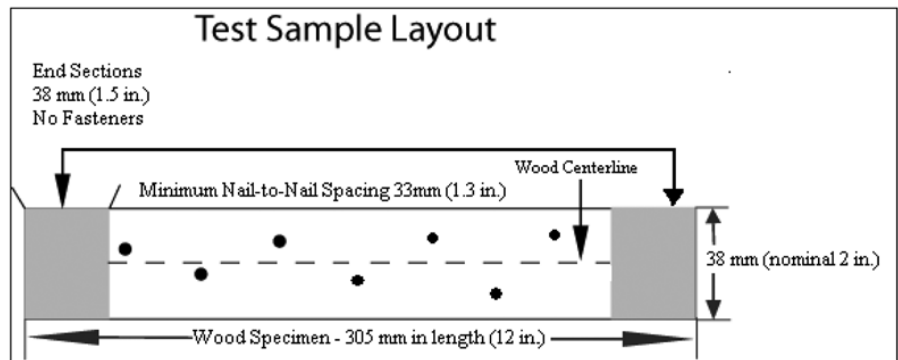
Wood test sample with driven nails is exposed to a cyclic salt test for 120 days. This is a far more severe test than the procedures used up to now.
