ARMORGALV® EXCELLENT RESULTS

Below please see Tapcon parts that were coated with **ArmorGalv® BLUE**. Please note that the parts on the right were drilled into concrete and removed and still exhibit the blue color after 48 hours of salt spray. The **ArmorGalv®** Base Coat will allow ANY paint to exhibit this phenomenon because it acts like a “sponge” to absorb paint BELOW the surface. The next pages shows the drilled parts after 1,300 hours of salt spray.

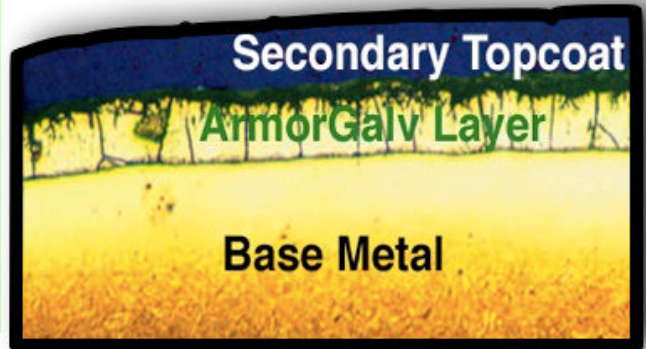
This explains why the **ArmorGalv®** BLUE can retain paint even after drilling:

Notice that the paint penetrates into the "fissures" of the **ArmorGalv®** surface. This prevents lateral corrosion pathways when the paint is compromised or damaged, thus eliminating paint-peel.
